**Coal Combustion Waste Impoundment  
Round 7 - Dam Assessment Report**

***Black Dog Power Station***

***Surface Impoundments***

**April 2011**

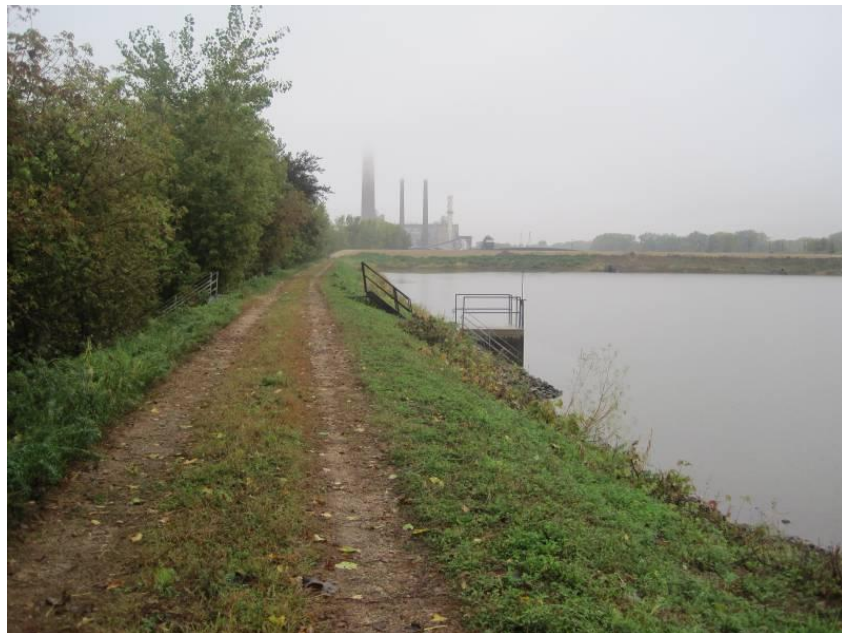
The crest of the embankment had no signs of significant depressions, tension cracks or other indications of settlement or shear failure. Figure 5.2.1-1 and Figure 5.2.1-2 show the typical crest condition of the embankment along Pond 3 and Pond 4, respectively.

**Figure 5.2.1-2:** Crest of embankment looking west; Pond 4 is to the right and Black Dog Lake is to the left; Crest does not serve as the flood control berm; Note the flood control berm wrapping to the right in the distance around Ponds 3, 2, and 1, which are not shown in the photo

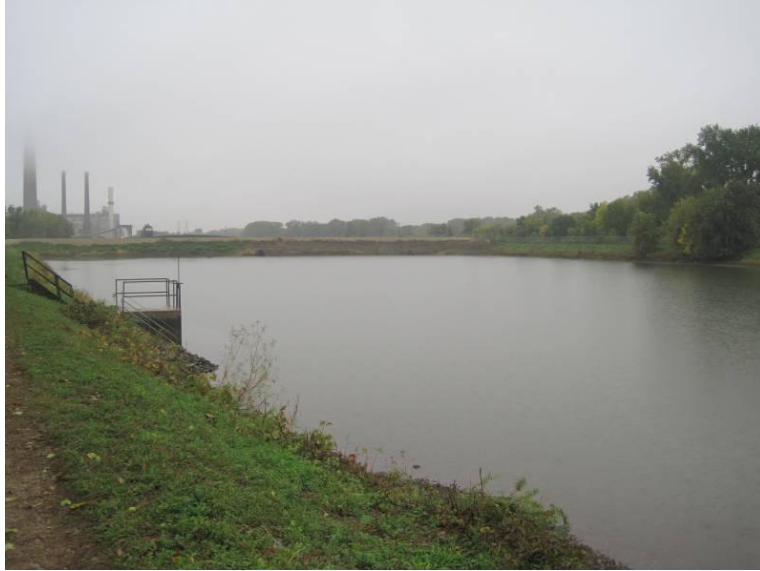
The inside slope of the embankment, including all groins, had a coverage of mixed grasses/weeds and gravel adjacent to Pond 3, and mixed grasses/weeds adjacent to Pond 4. There were no observed scarps, sloughs, bulging, cracks, depressions or other indications of slope instability. Figures 5.2.2-1 and 5.2.2-2 show a representative section of the embankment looking east and west from Pond 3 and Pond 4, respectively.

**Figure 5.2.2-2:** Inside slope of embankment looking west; Pond 4 is located to the immediate right

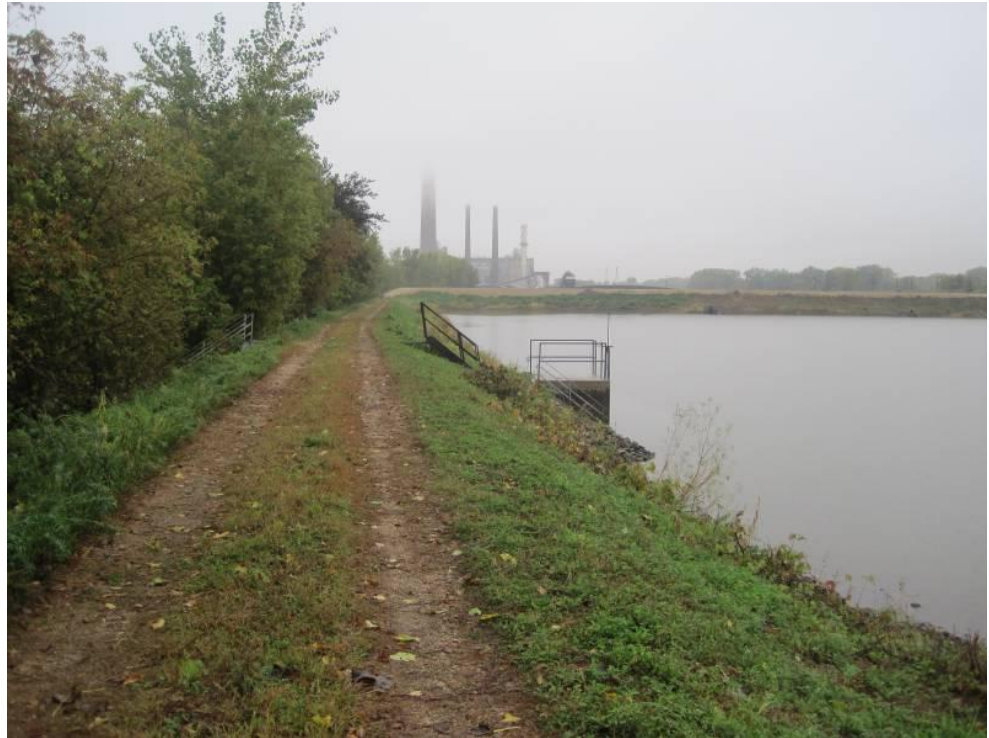
The outside slope of the embankment is vegetated with various species of tall grasses and weeds. The toe of the embankment follows the shoreline of Black Dog Lake where there are trees also growing. Heavy overgrowth along the outside slope of the embankment and toe made close observation of the embankment difficult. Based on what could be observed there were no scarps, sloughs, bulging, cracks, depressions or other indications of slope instability. Figures 5.2.3-1 and 5.2.3-2 show a representative section of the embankment looking west from Pond 3 and Pond 4.

**Figure 5.2.3-2:** Outside slope of embankment to the left looking west;  
Pond 4 is located to the immediate right

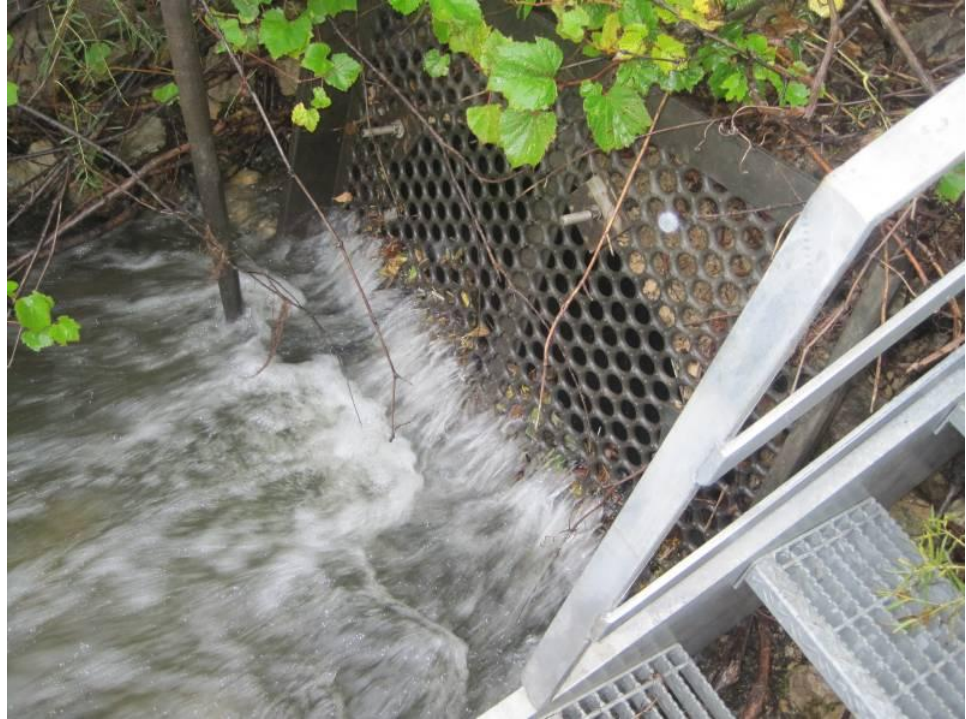
The outlet conduit consists of a 42-inch pipe with a trash rack on its downstream outfall at Black Dog Lake. The conduit appeared to be in good shape with no visible signs of clogging and the water exiting the outlet was flowing clear. Figure 5.3.2-1 shows the outfall of the outlet conduit.

**Figure 5.3.2-1:** Outfall of outlet conduit in operation

A separate emergency spillway was not observed. It is unclear, based on the documentation provided, if the overflow spillway also serves as the emergency spillway for the impoundment (i.e. a combined drop-inlet principle/emergency spillway). After NSP-M reviewed the draft version of this report, NSP-M confirmed that the only outlet from pond 4 is the outfall shown in Figure 5.3.2-1.

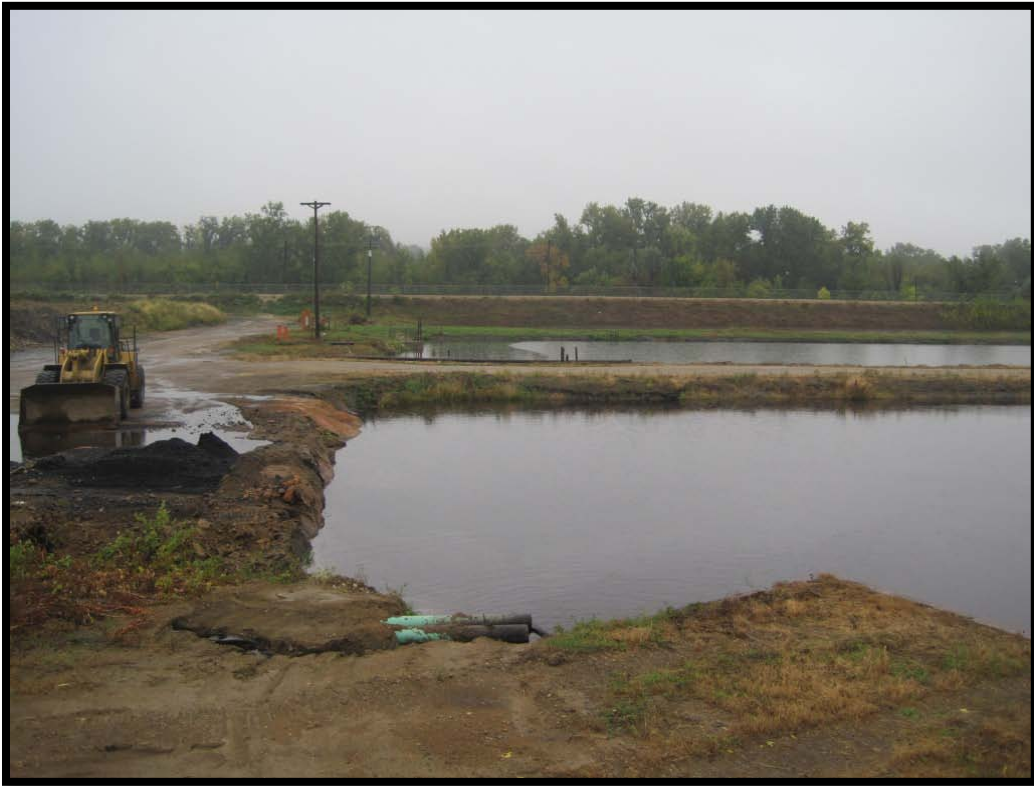
**Figure 1: Ash Water and Bilge Line Outlet to Process Water Settling Pond # 3**

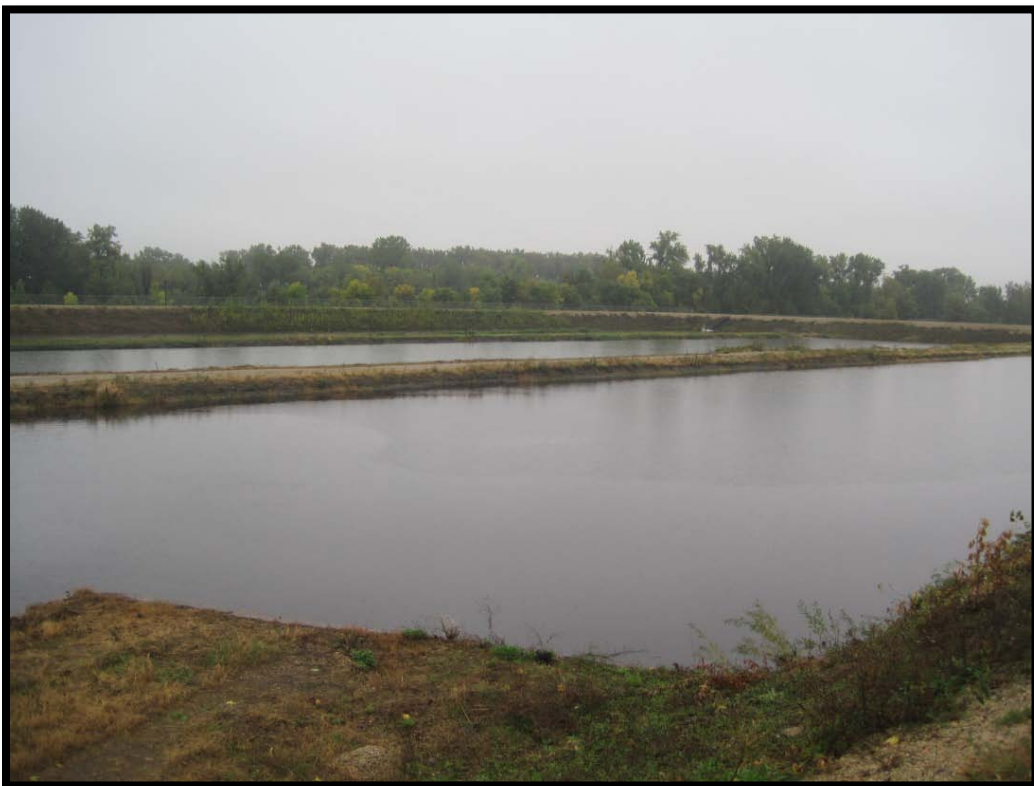
**Figure 2: Process Water Settling Pond # 3, Northeast**

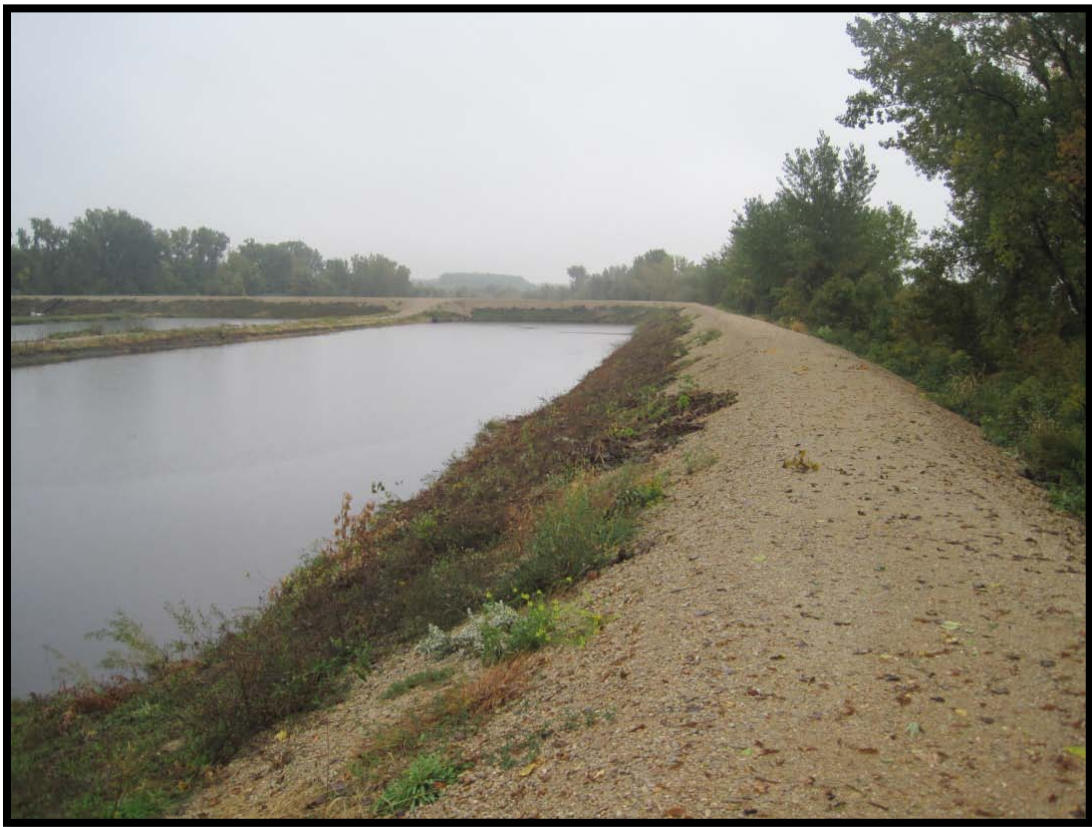
**Figure 3: Process Water Settling Pond # 3, East**

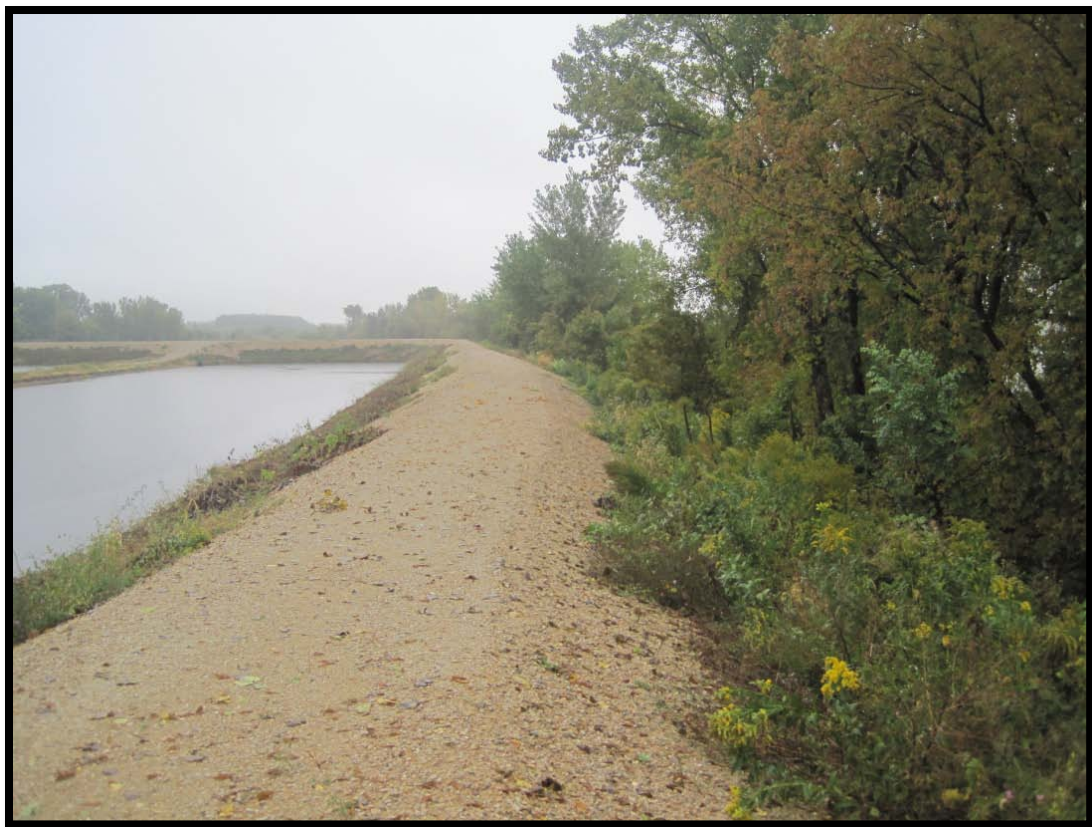
**Figure 4: Process Water Settling Pond # 3, East**

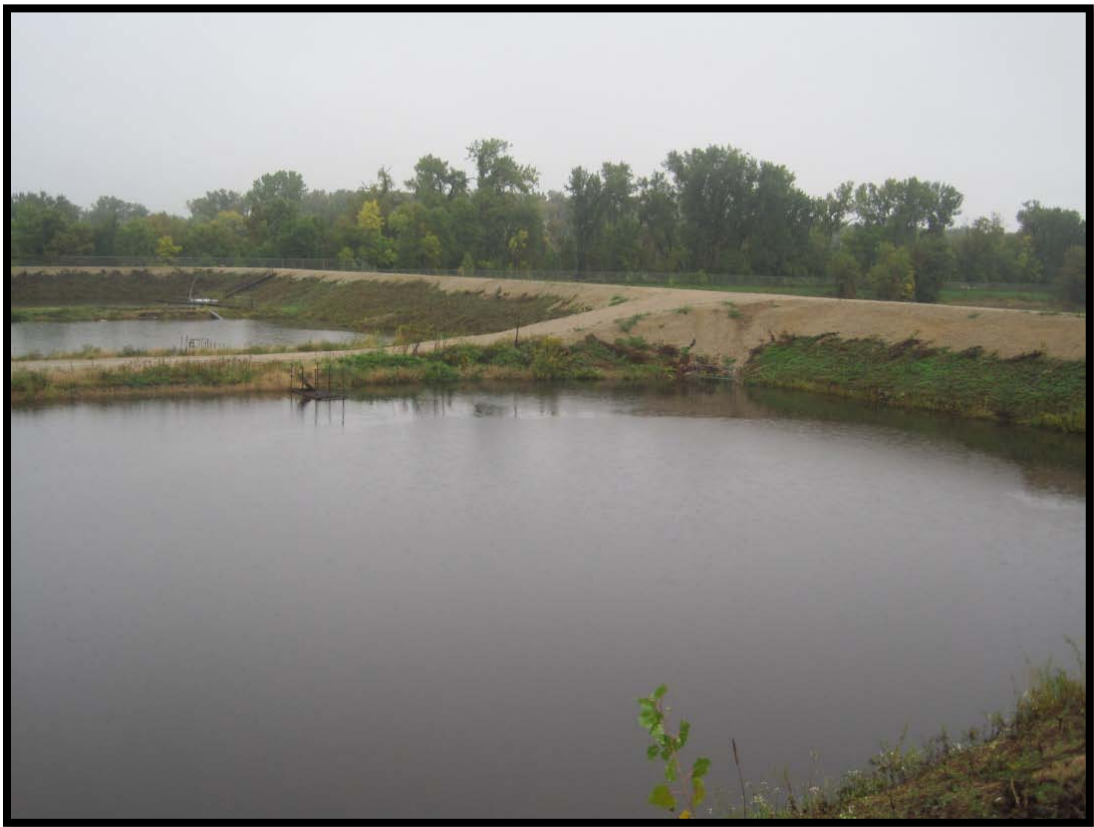
**Figure 5: Process Water Settling Pond # 3, North**

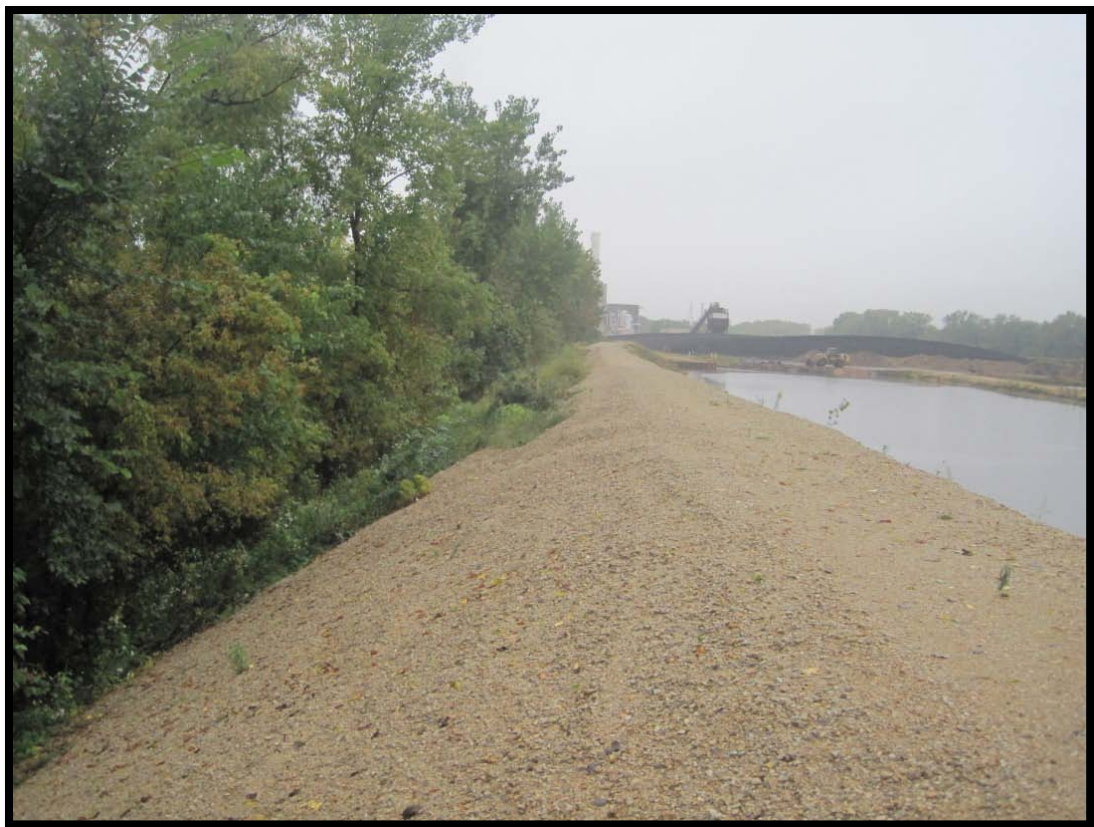
**Figure 6: Process Water Settling Pond # 3, West**

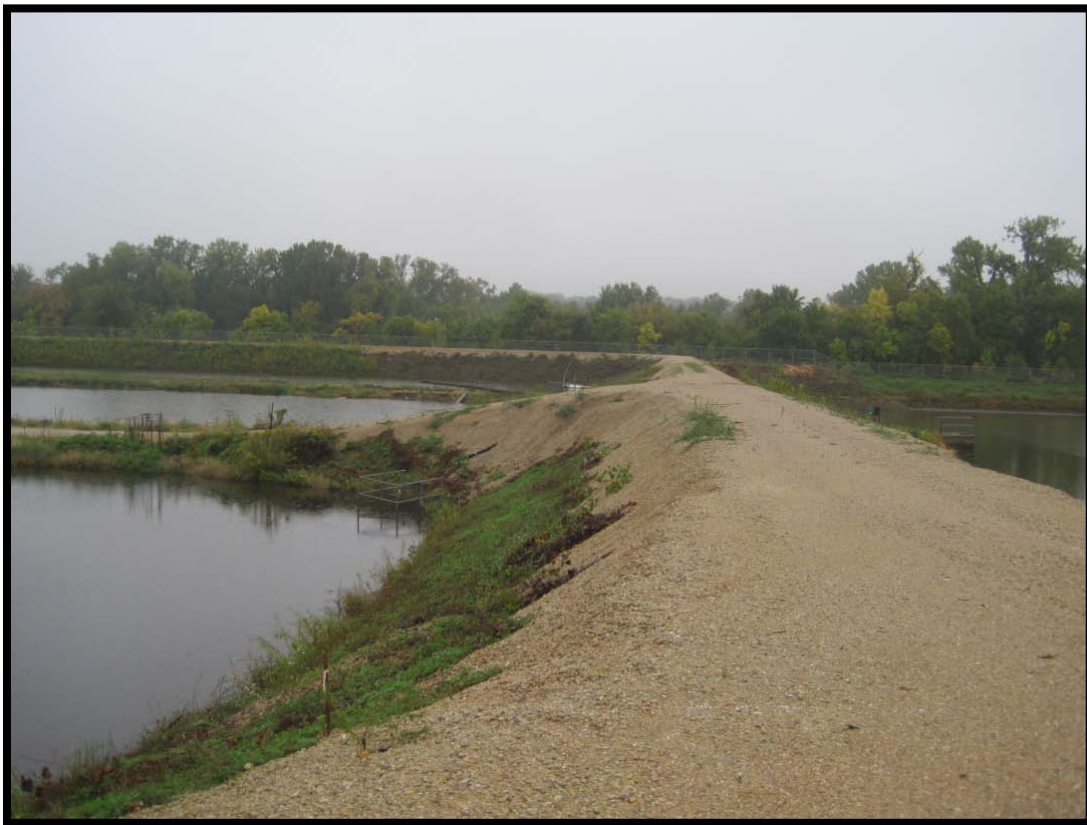
**Figure 7: Process Water Settling Pond Divide for Ponds #1-#3 and #4, Northwest**

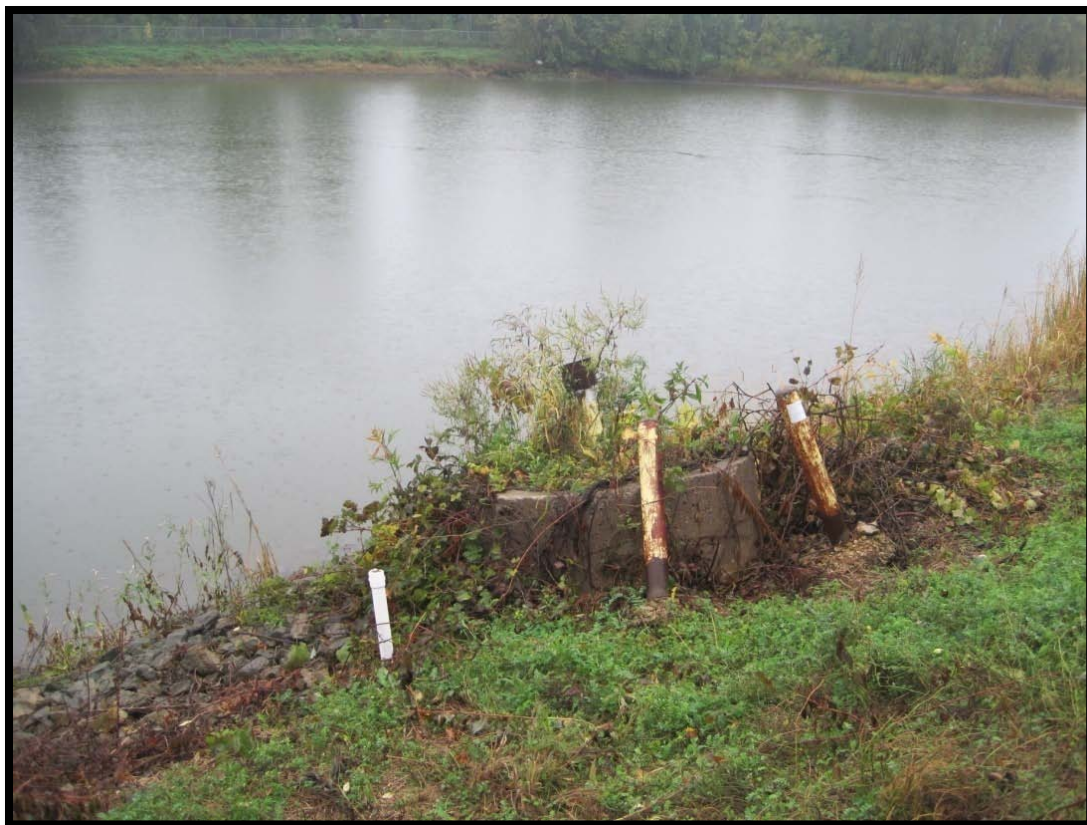
**Figure 8: Process Water Settling Pond # 4, North**

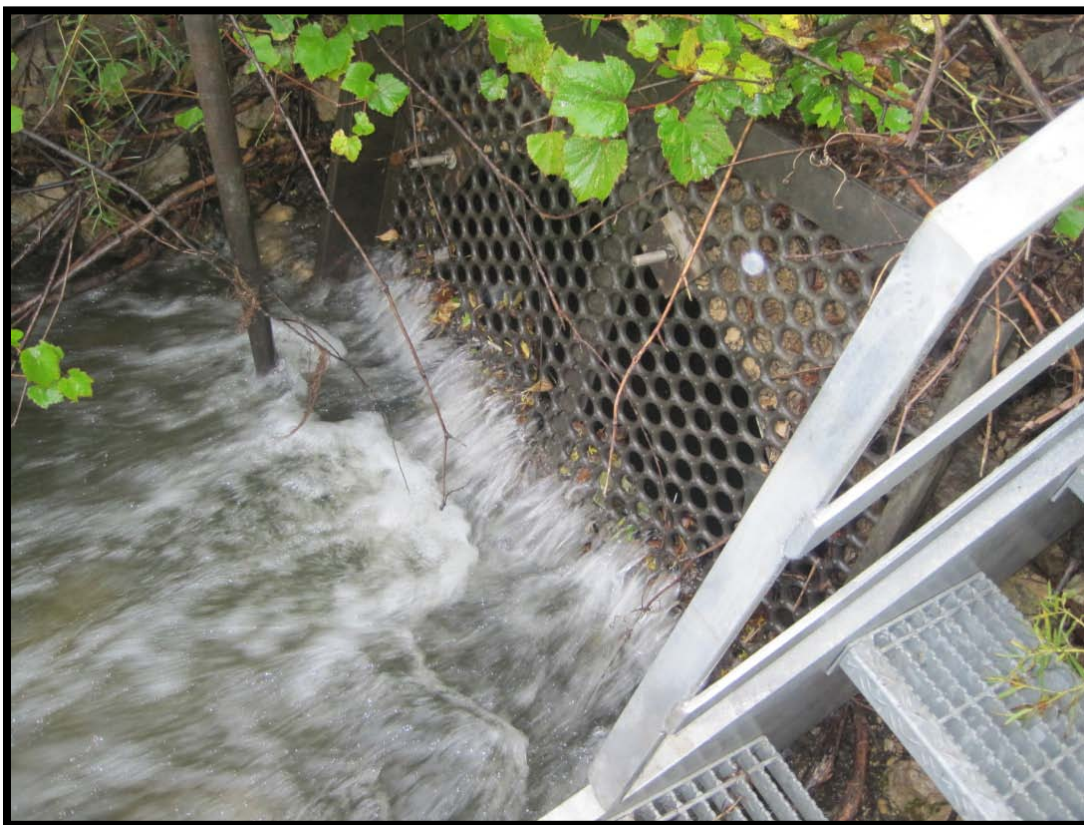
**Figure 9: Process Water Settling Pond # 4 Outlet to Black Dog Lake**

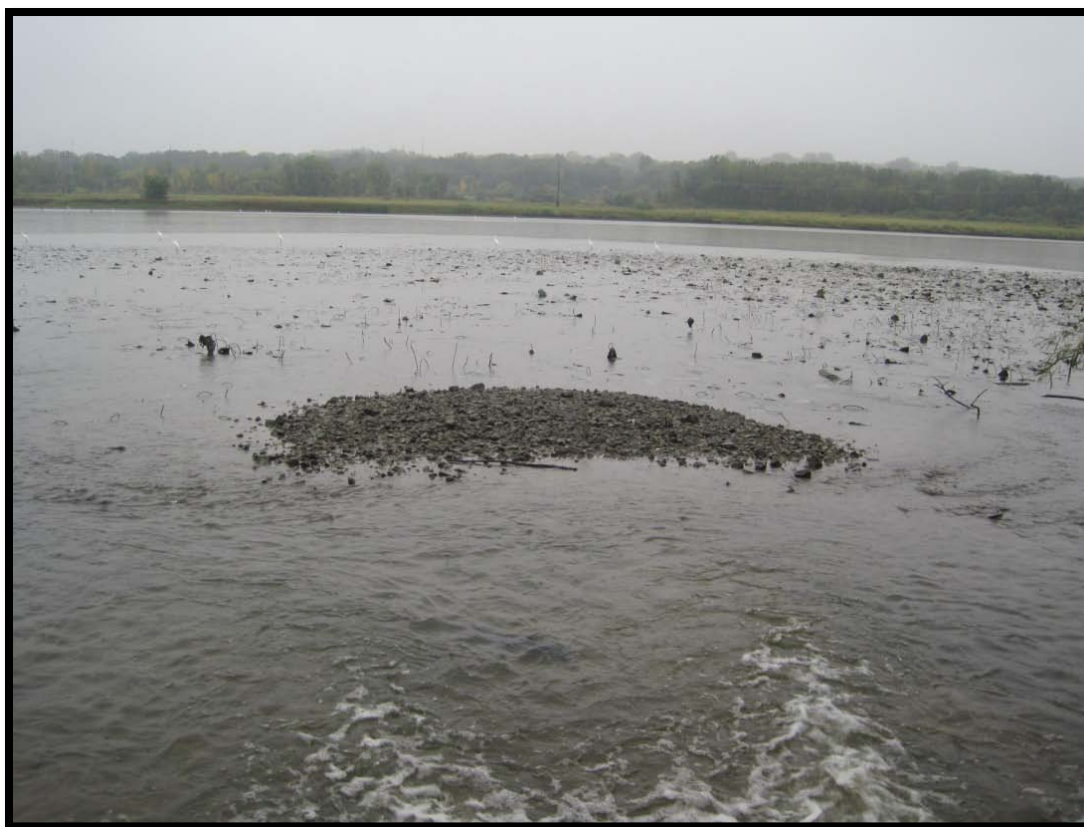
**Figure 10: Black Dog Lake at Process Water Settling Pond # 4 Outlet**

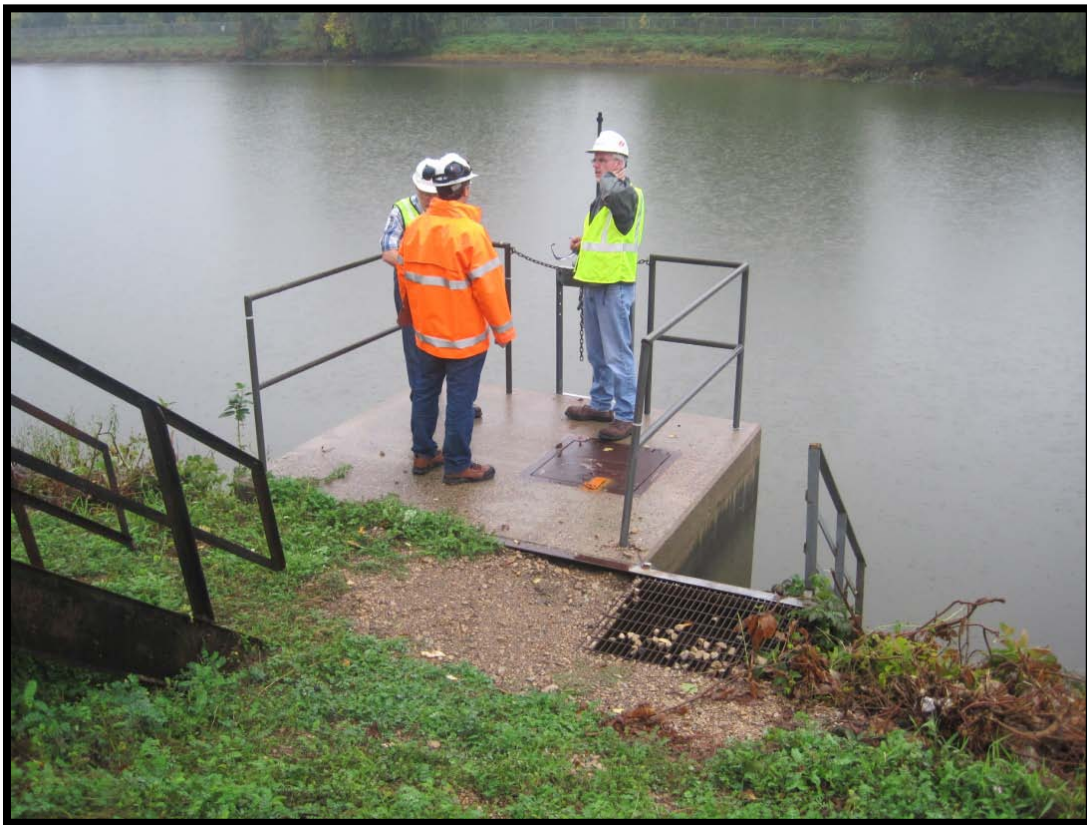
**Figure 11: Process Water Settling Pond # 4 Inlet to Black Dog Lake**

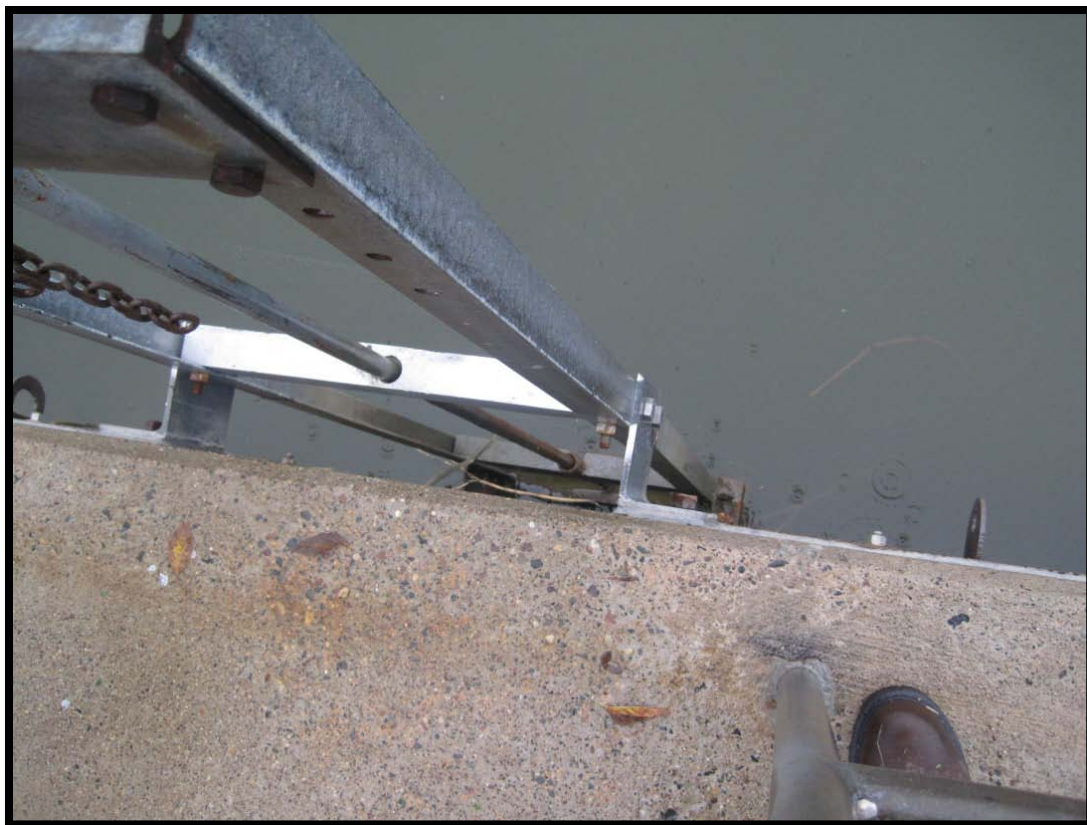
**Figure 12: Process Water Settling Pond # 4 Access Ladder for Inlet to Black Dog Lake**

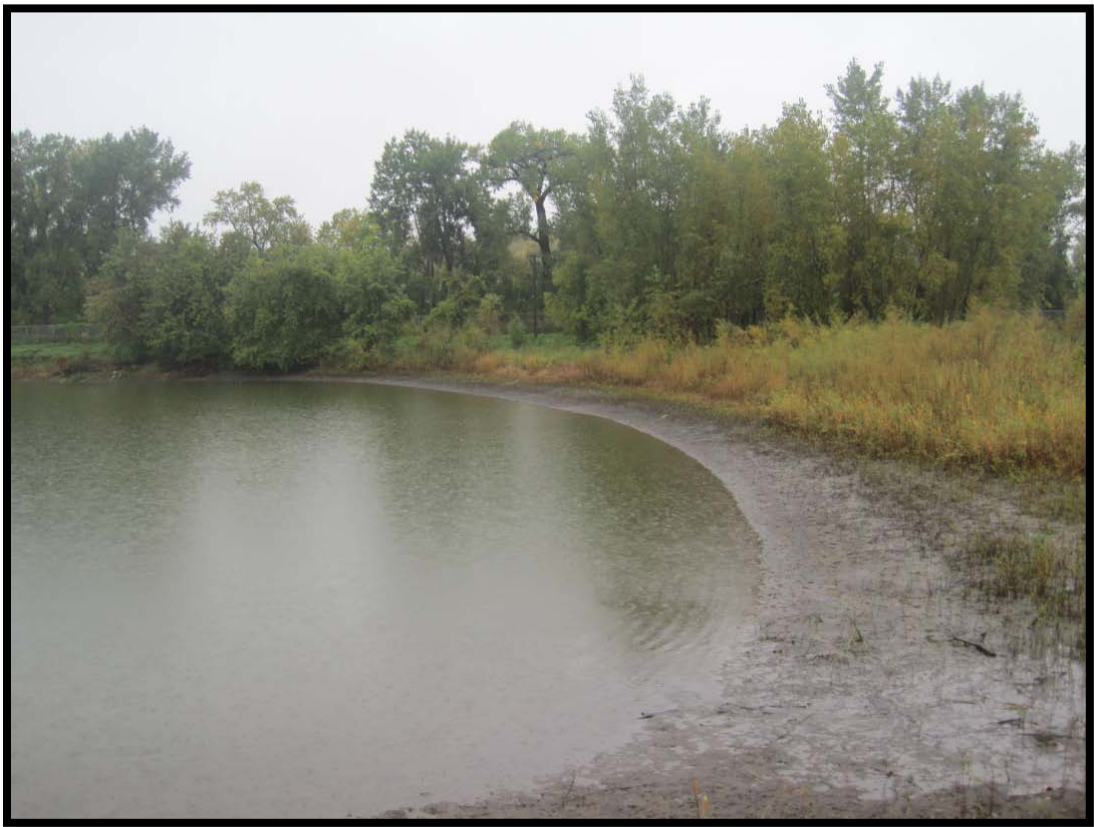
**Figure 13: Process Water Settling Pond # 4, North**

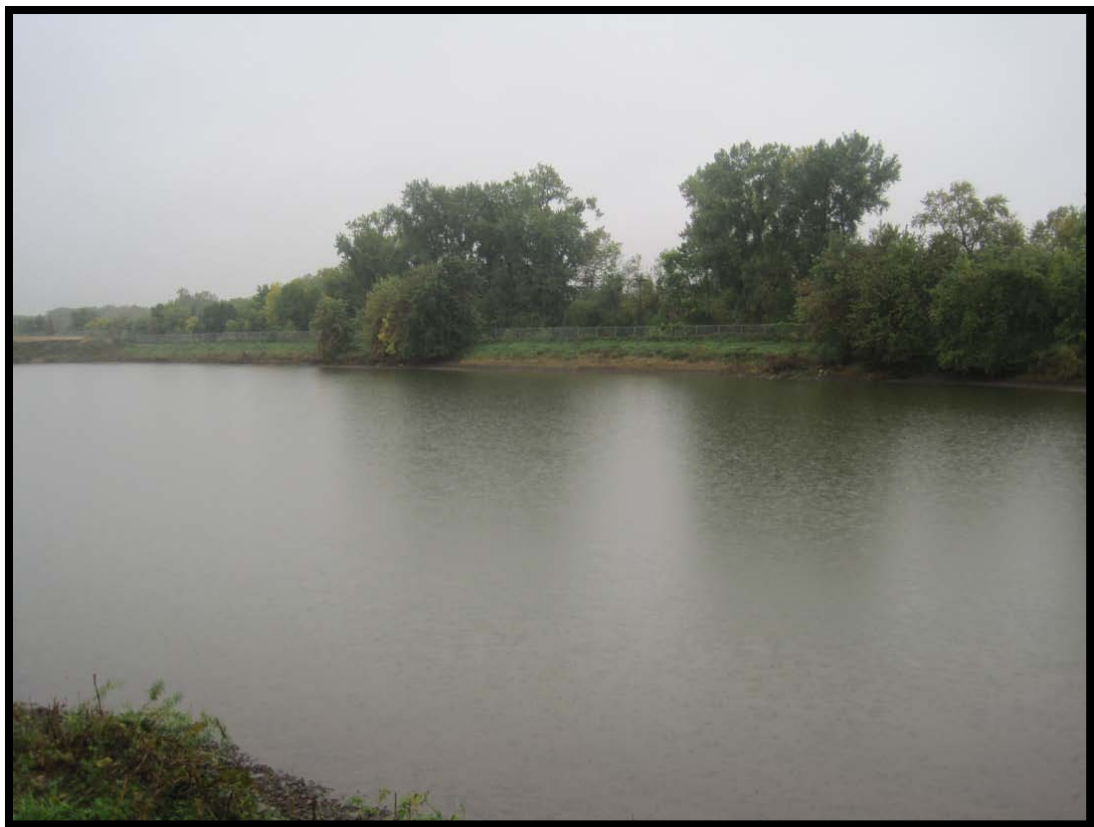
**Figure 14: Process Water Settling Pond # 4, Northwest**
